TECHNICAL NOTE 4030

EXPERIMENTAL INVESTIGATION OF CERMET TURBINE BLADES  
IN AN AXIAL-FLOW TURBOJET ENGINE

By William C. Morgan and George C. Deutsch

October 1957

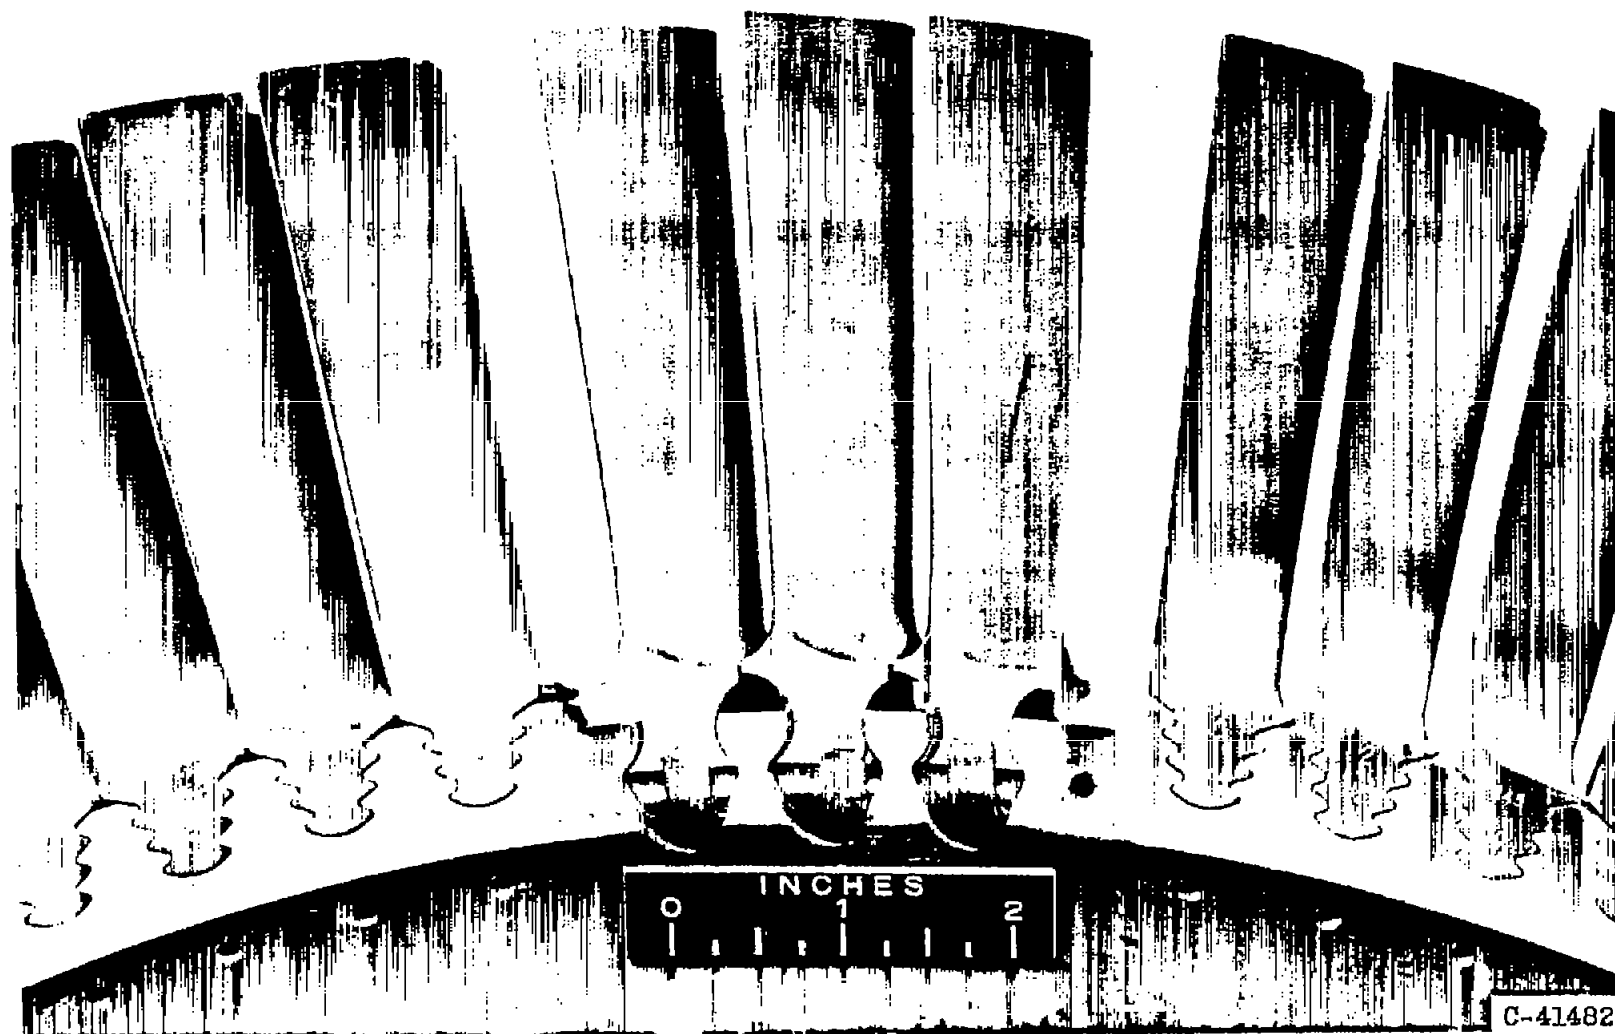
(c) Vibration may have been more serious in the six-blade tests. The spacing between the outer blades of a cluster of three and the adjacent metal blades was not a normal condition (fig. 2). In the course of a concurrent program on light-weight metal blades one test blade was placed in the space normally occupied by two blades. This metal test blade failed because of fatigue in the tip after a short time; blade life was less than 2 percent of the time for similar test blades in standard spacing.

Figure 2. - Three cermet turbine blades mounted in space normally provided for four standard metal blades.

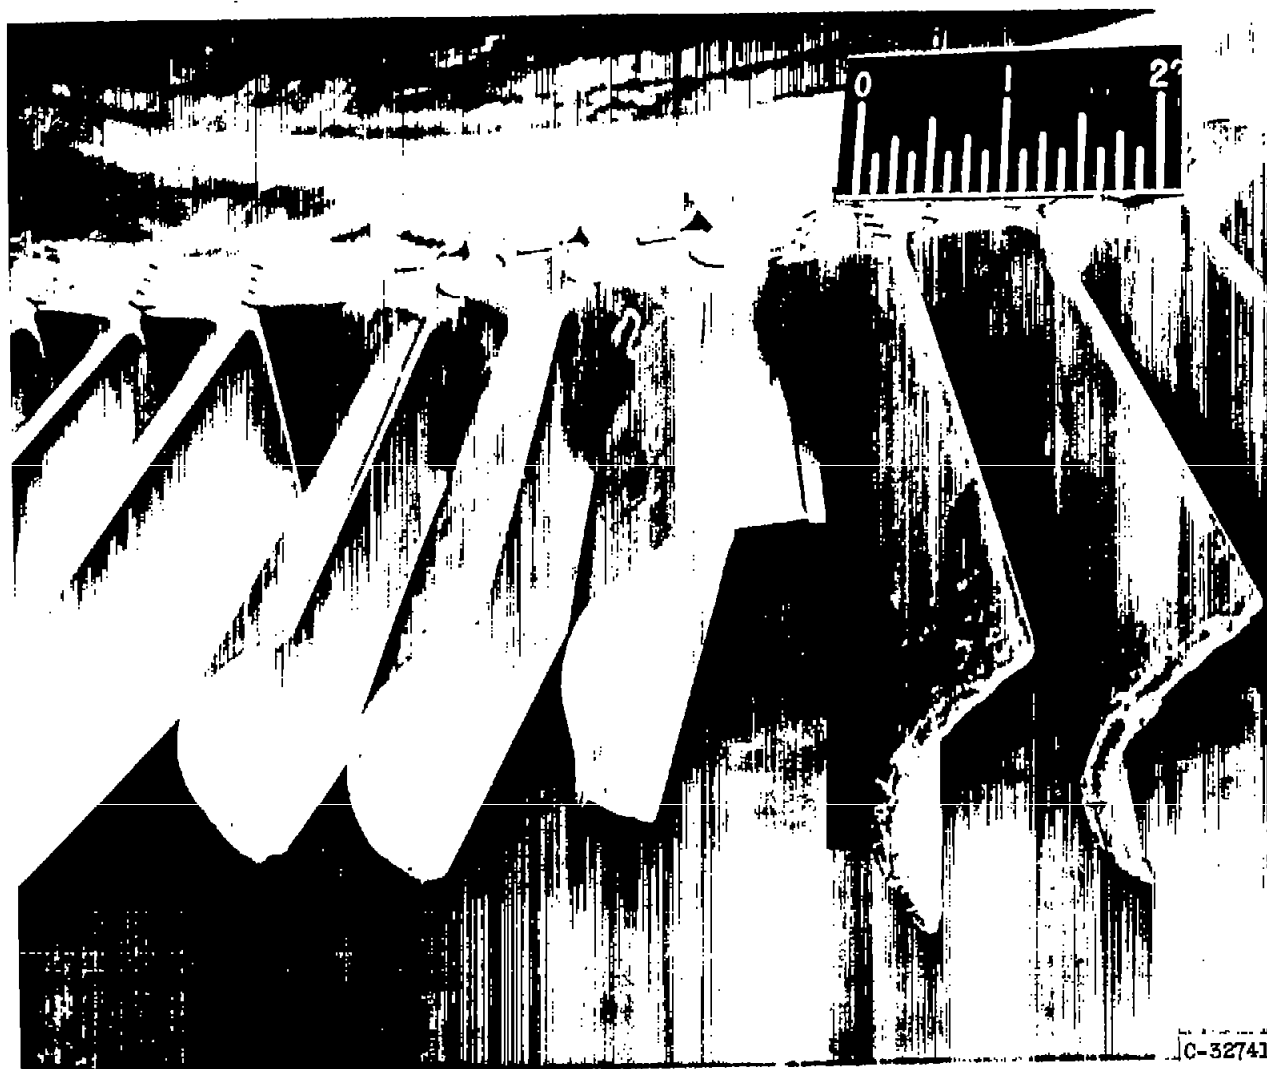
Table I gives operating time, number of starts, test conditions, and brief description of failure. In most of the early tests the blades were damaged in the tip region (tests 1 to 4 and 7). Figure 5 shows a typical failure. There are two possible causes for these failures, impact and fatigue.

Damage may have been caused by the impact of carbon fragments passing through the turbine. For example, hard carbon deposits were found in the combustion chambers in amounts considered excessive. This was a condition peculiar to the individual test engine. Figure 6 shows a piece of carbon removed during inspection. The deposits were not homogeneous, varying from a soft and amorphous material to a silver-gray substance comparable to industrial limestone slag. Spectroscopic analysis did not indicate the presence of material other than carbon.

Fatigue was considered as the other possible cause of blade failure. Damage occurred principally as tip failure. Metal turbine blades fail in this area as a result of excessive vibration, and this lends credence to the possibility of fatigue damage to cermet blades.

Figure 5. - Blade failures in test 1 after 1 hour and 25 minutes at maximum turbine speed, typical of runs 1 to 4 and 7.

The substitution of gasoline for standard fuel made some improvement in maximum blade life. It was used in tests 5, 6, 9, 9a, 12, 13, and 14. Test operation of 43 hours and 57 minutes was obtained in test 14 before occurrence of failure. Periodic inspection showed that carbon formation was low. In tests where standard fuel was used, with the exception of tests 15 and 16 where test conditions were radically different, the maximum blade life was 19 hours and 27 minutes (test 8).

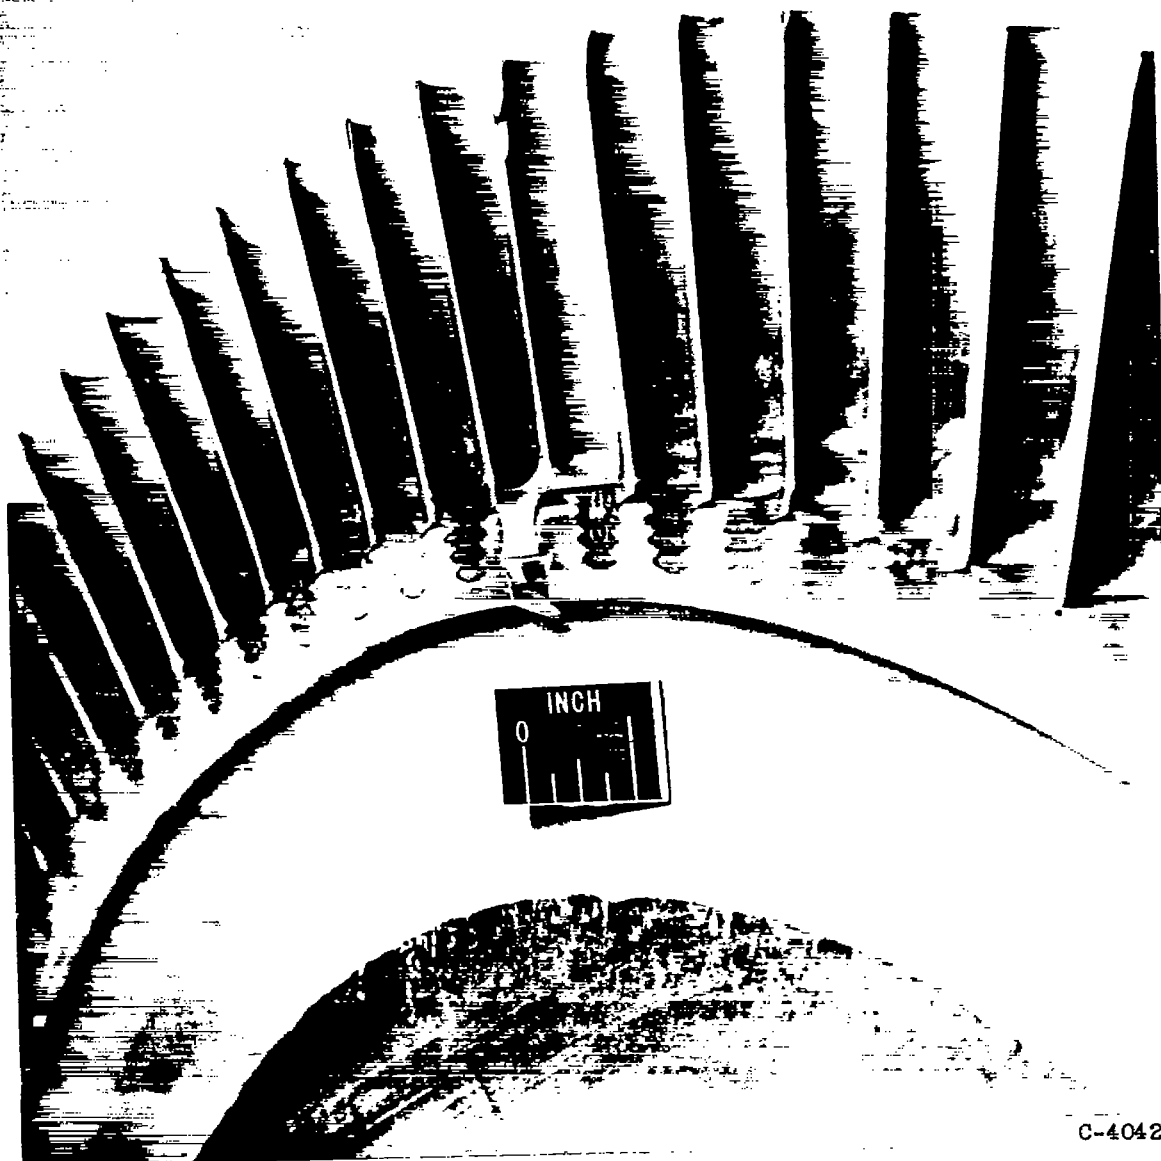
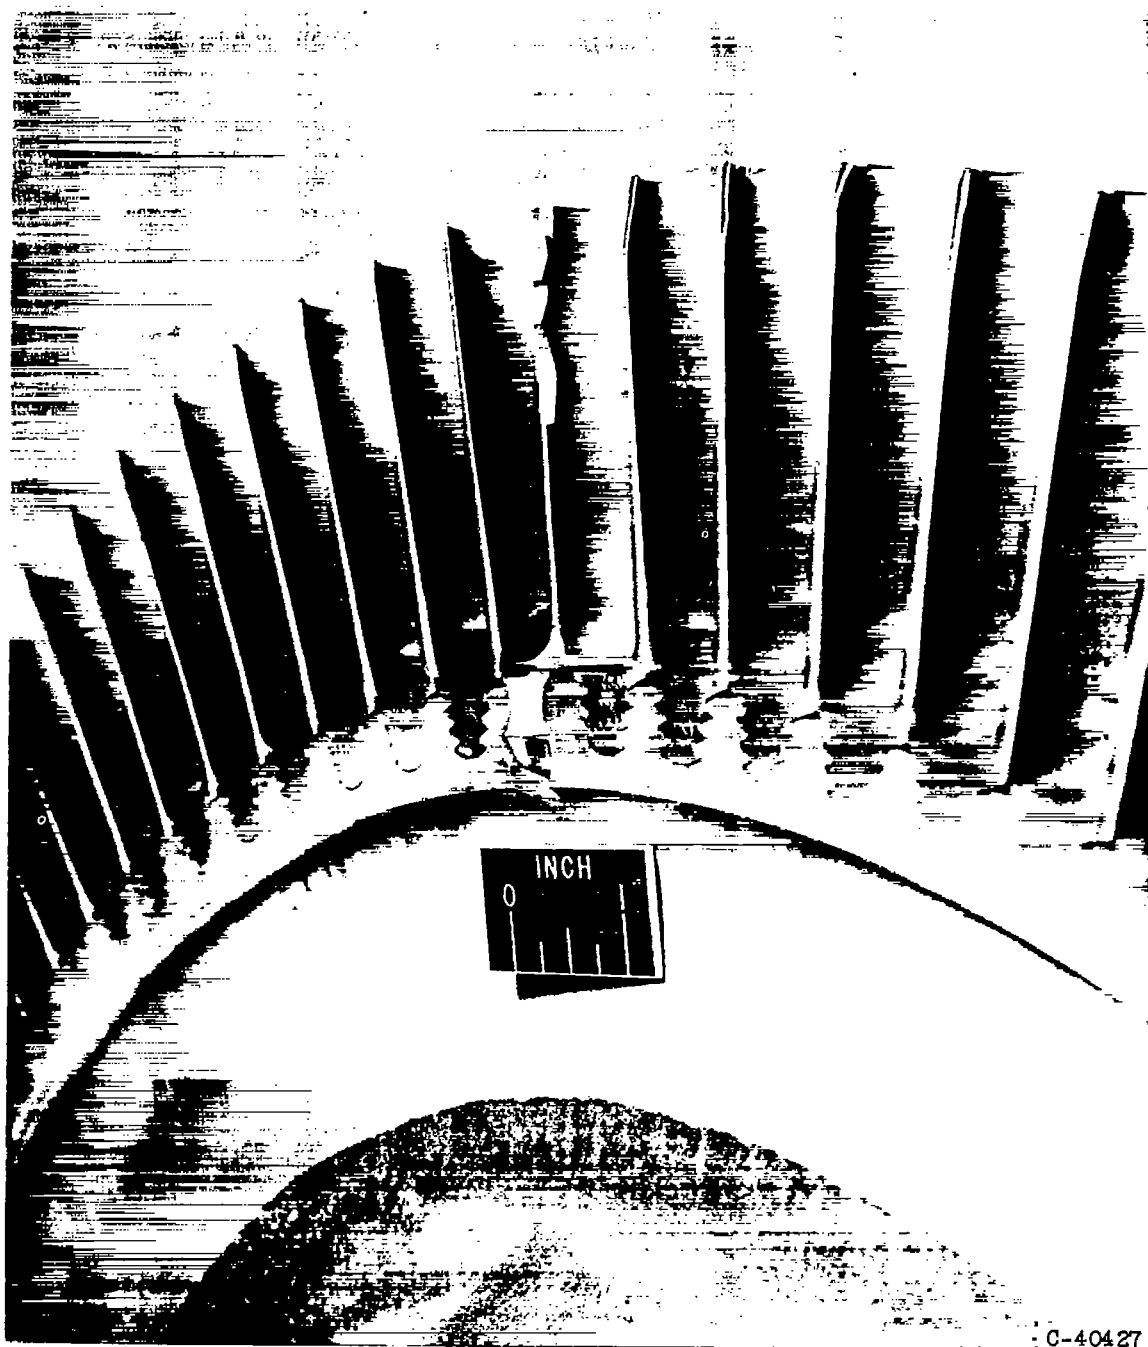
The best performances of cermet blades were obtained in tests 15 and 16, using the rotor modified for two test blades in standard spacing. The blades in test 15 had 1/4-inch radii at the tips. This test was discontinued after 150 hours at a turbine speed of 7950 rpm and exhaust temperature of 1260° F. One blade from test 15 lost a small chip from the tip (leading edge) after 84 hours and 34 minutes; the other blade was chipped in the same location after 97 hours and 38 minutes. Chipping continued during the remainder of the test. The extent of damage at the end of 150 hours is shown in figure 7.

Figure 7. - Cermet blades from test 15 after 150 hours at maximum turbine speed.

Figure 7. - Concluded. Cermet blades from test 15 after 150 hours at maximum turbine speed.

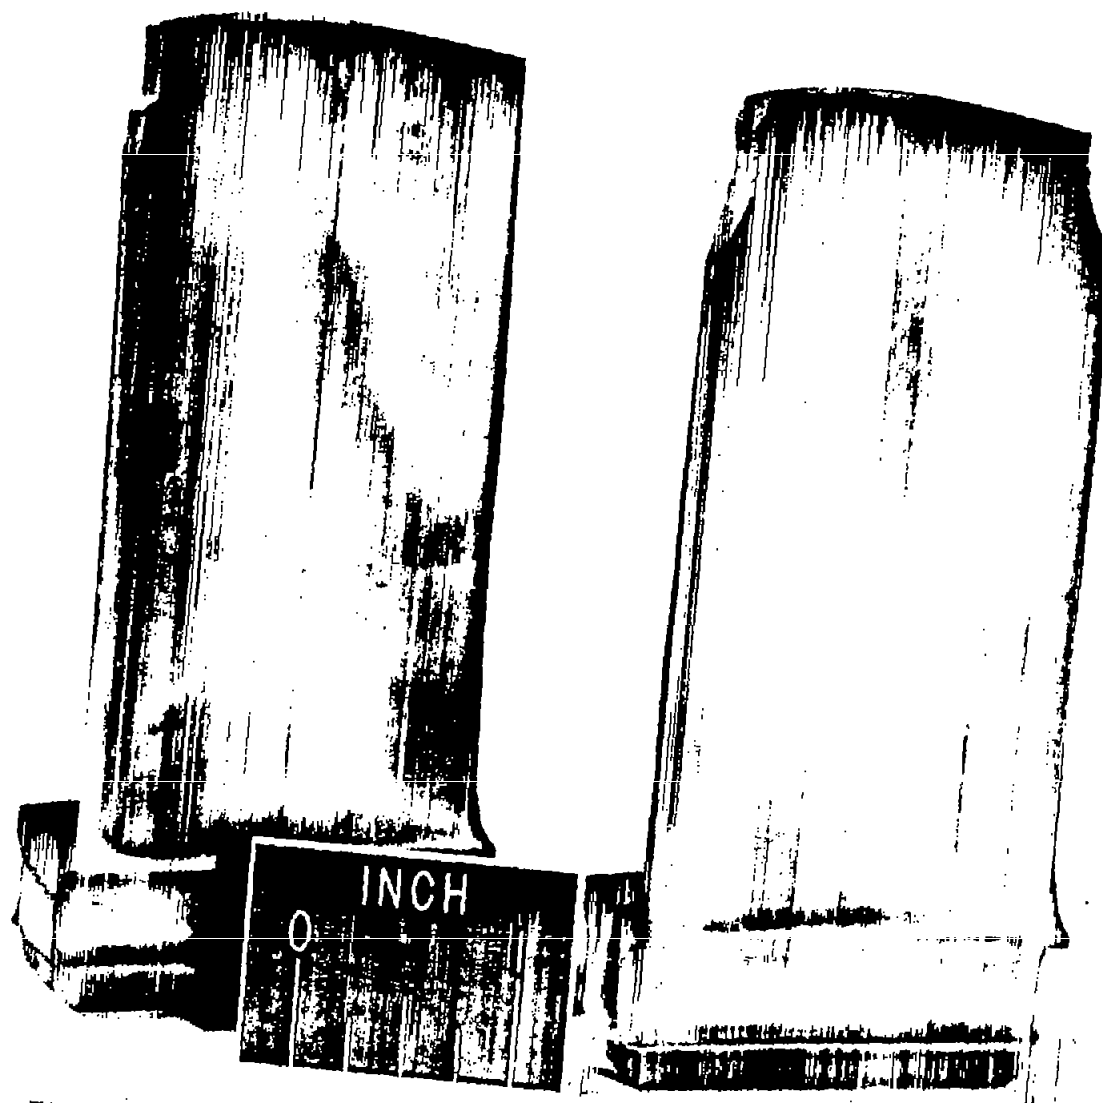
The two blades of test 16 were not modified. The test was ended after 150 hours and 30 minutes at the maximum conditions of operation. Initial chipping was observed in the leading edges of both blades and the trailing edge of one after 41 hours and 50 minutes. Damage was confined to the tip region. Figure 8 shows the total extent of damage at the end of the test.

Figure 8. - Cermet blades from test 16 after 150 hours 30 minutes at maximum turbine speed.
